DIAGNOSING NO_x FAILURES PART II

Gary Stamberger – Training Director
Magnaflow Exhaust Products

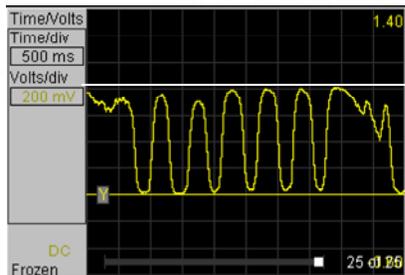
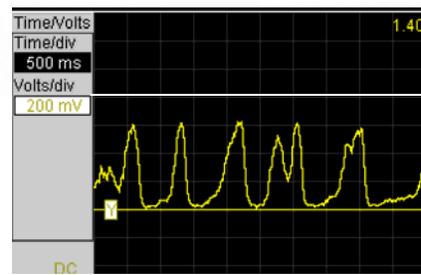
In the example on the left we are peaking at 800mV or .8volts (Normal Operation). The one on the right shows the same vehicle under a lean condition. Notice the peak voltage barely reaches 600mV (.6volts) indicating a system that is bias lean. This condition may not cause the PCM to trigger an O₂ code but the extra oxygen could affect the converters ability to reduce NO_x.

Too many times something that seems so minor can have the greatest impact when it comes to repairing a particular problem. The wave forms in the examples above were created by adjusting the MAF frequency by only 300hz. This deviation did not set a code and the vehicle for the most part ran OK. The PCM is programmed to maintain drivability and this can leave the technician thinking “since the car is running OK, all must be well”. This false assumption could lead to the replacement of a perfectly good Converter.
